## **Building Performance Evaluation**

Green Residents  
12345 Energy Dr.  
Savings, MI. 48000

*YOUR HOME ENERGY AUDIT  
IDENTIFIES OPPORTUNITIES TO  
IMPROVE THE PERFORMANCE  
OF YOUR HOME BASED ON  
OUR ANALYSIS. THIS REPORT  
SUMMARIZES THE FINDINGS,  
PRIORITIZES RECOMMENDED  
IMPROVEMENTS, AND HELPS  
YOU DETERMINE  
THE BEST IMPROVEMENTS  
FOR YOUR HOME.*

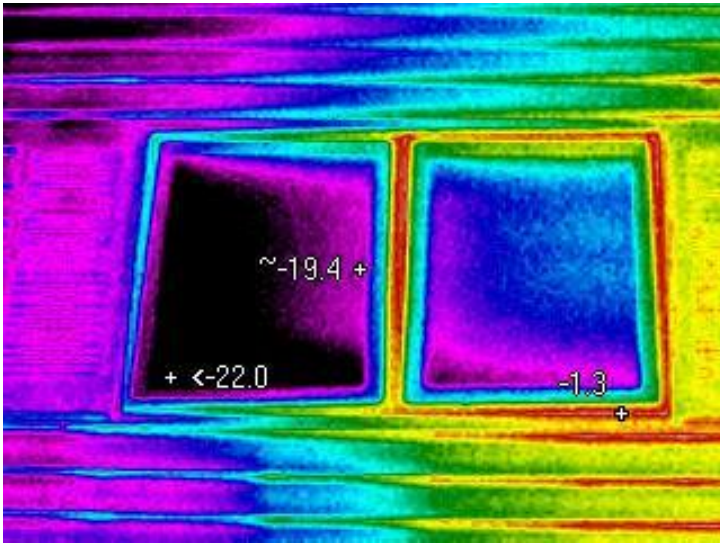
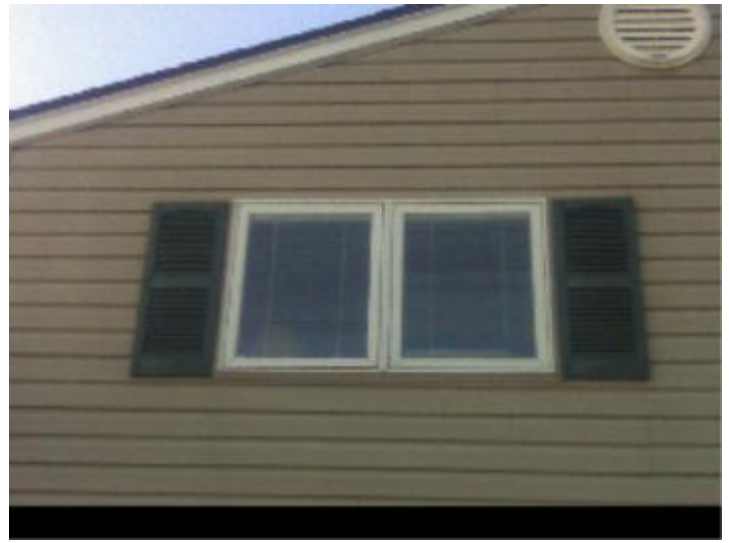
Thermal Image of Upstairs Window, notice yellow to red areas of the image is the Warmer areas of the image and the blue to purple-black the colder areas in the image. The images will always have the hottest and coldest areas marked.

Visible Image Upstairs window. Depending on the perspective of the picture taken warm spots are naturally a problem when viewing from the outside of the home and cold spots are a problem when viewing from the inside of the home.

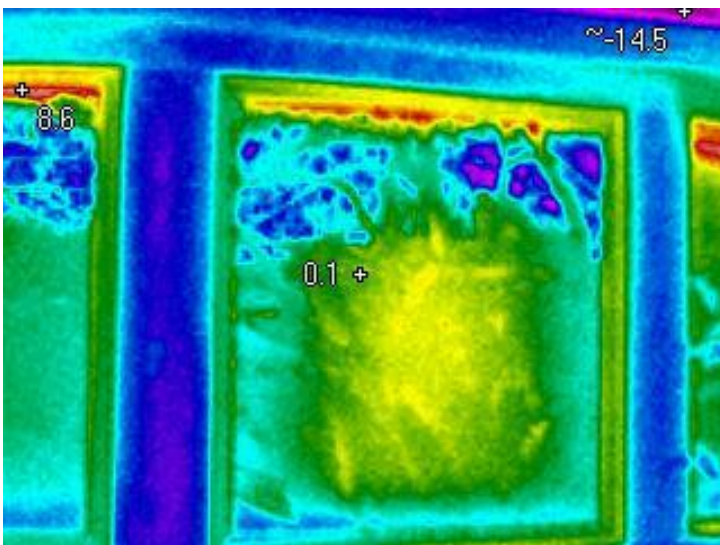
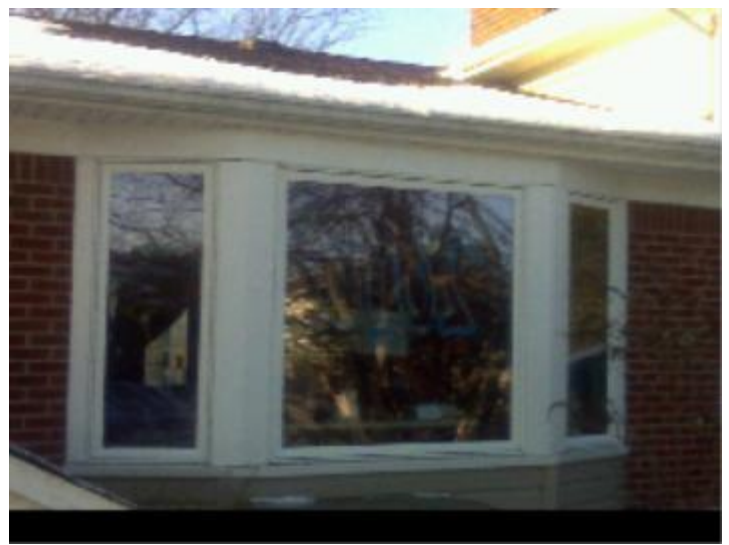
Thermal Image of bay window, notice some leakage at top of window.

Visible Image of bay window.

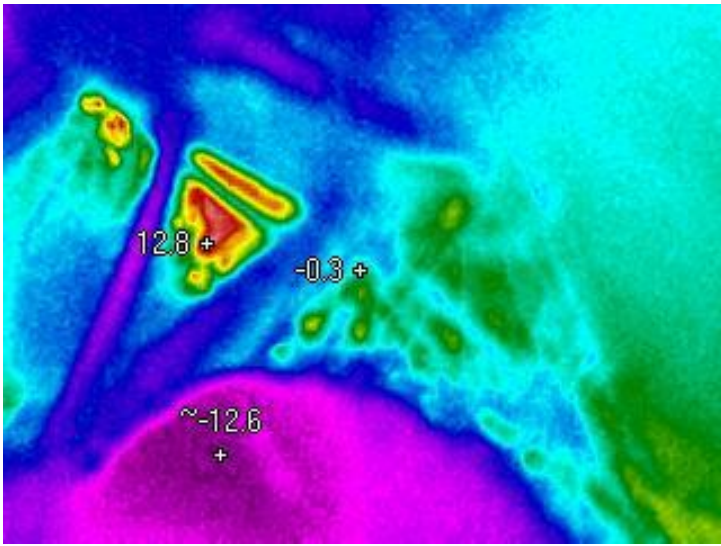
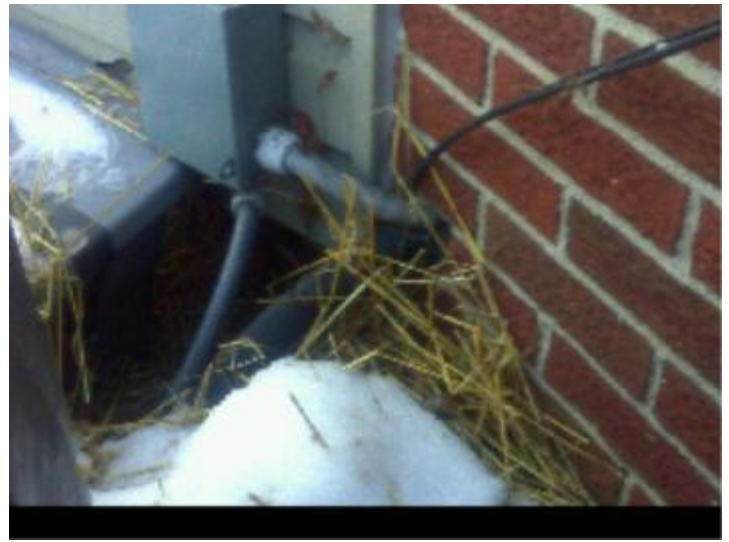
Thermal Image of Electrical wall penetrations need to be sealed properly.

Visible Image of Electrical wall penetrations.

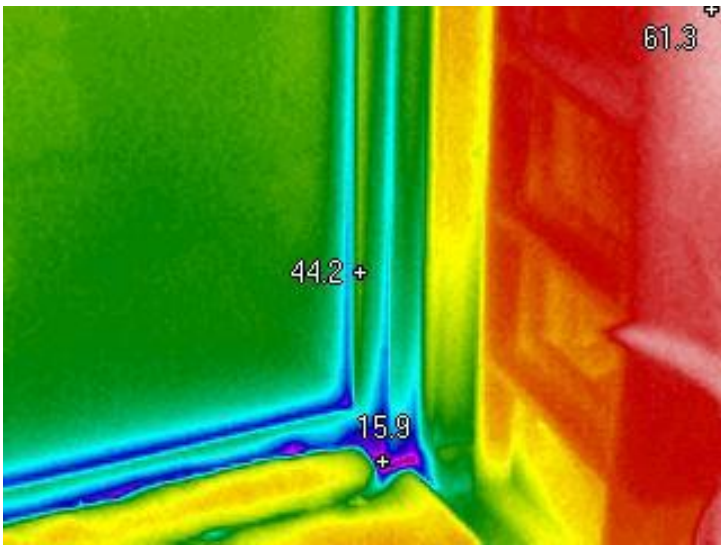
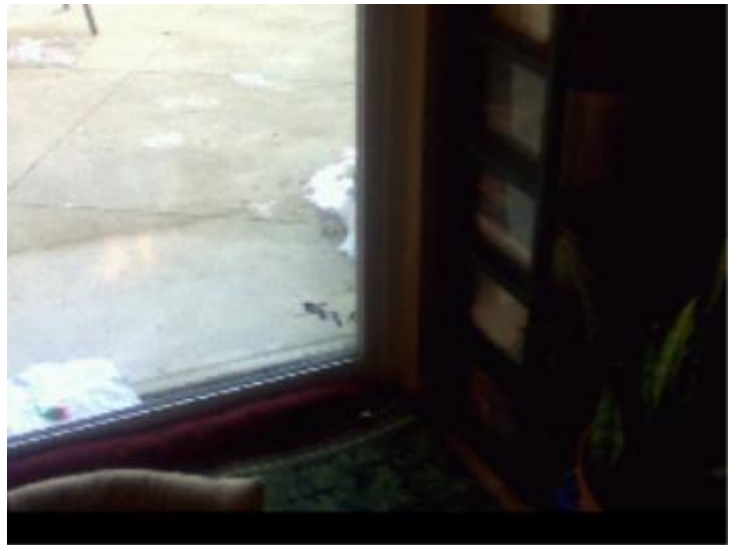
Thermal Image of sliding glass door needs to be sealed properly with added weather stripping.

Visible Image of sliding glass door.

## Priority: Medium! CRITICAL ISSUES: Sliding Glass Doors to be tightened up and weather stripping needs to be installed

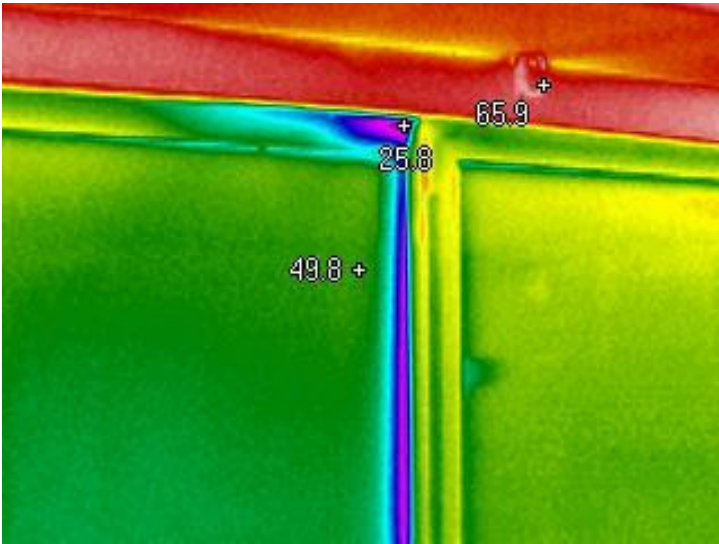
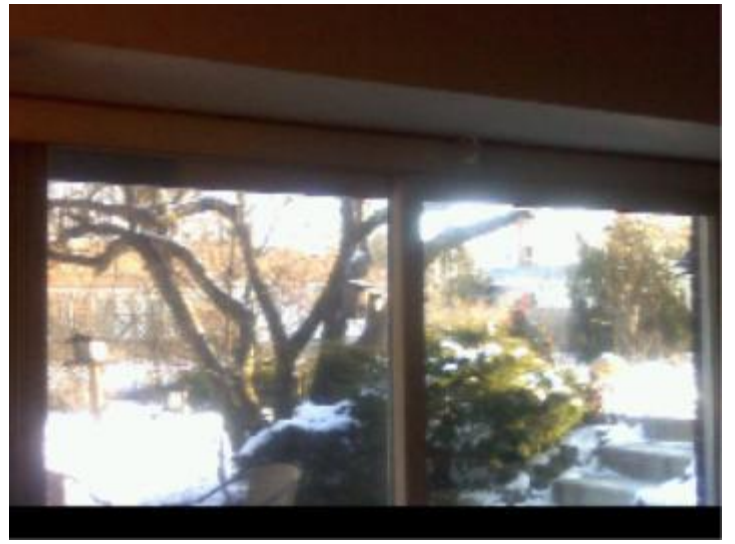
Thermal Image of sliding glass door needs to be sealed properly with added weather stripping.

Visible Image of sliding glass door.

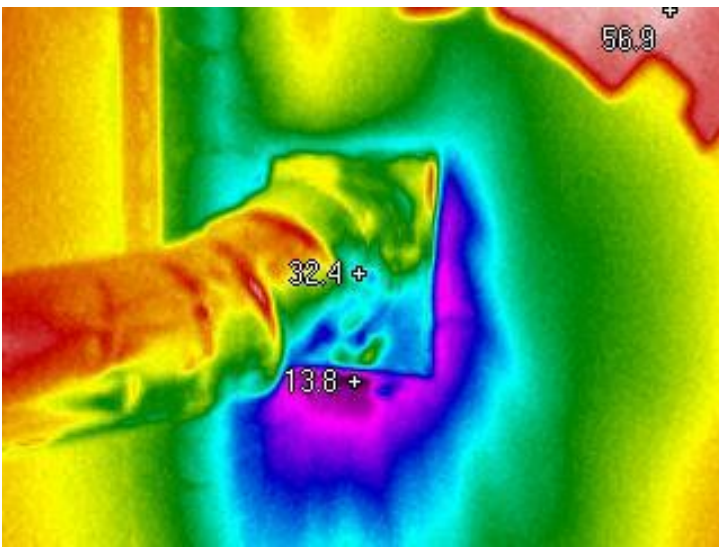
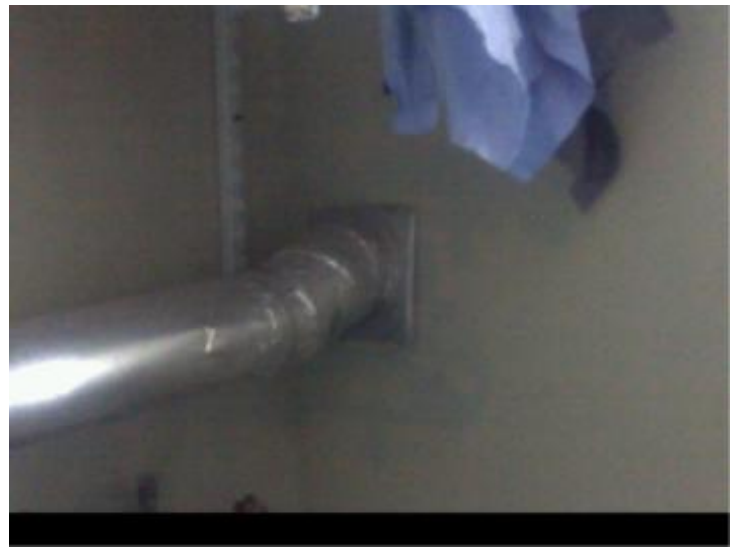
Thermal Image of dryer vent needs to be secured properly to wall plus add gasket, proper sealing.

Visible image of dryer vent.

- Multiple exterior wall penetrations have inadequate or deteriorating sealant
- Most noticeably is the Dryer vent exhaust
- Recommend Sealing and Stabilizing Dryer Vent Exhaust Termination.
- A couple of cans of spray foam can resolve many of the HVAC PVC wall penetrations, Savings of up to 10% on your heating and cooling bill can be achieved by reducing the air leaks in your home.

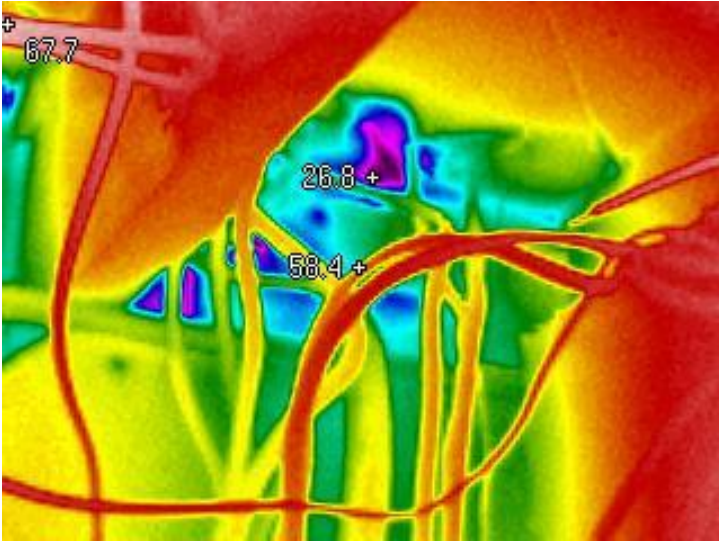
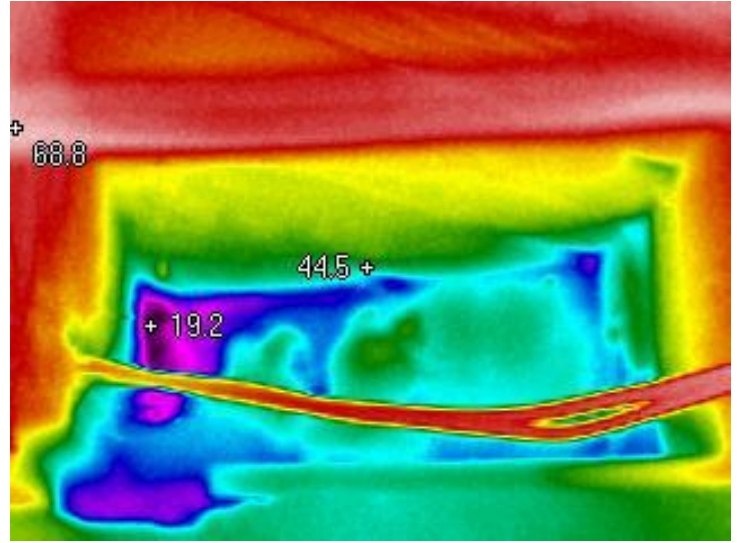
Thermal Image of above the electrical breaker pane, needs to be sealed, allowing outside air infiltration into home.

Visible Image of wall penetration in basement.

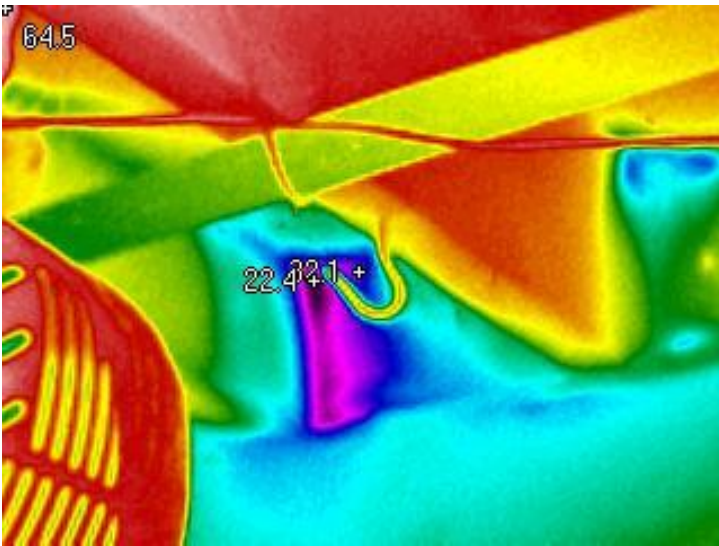
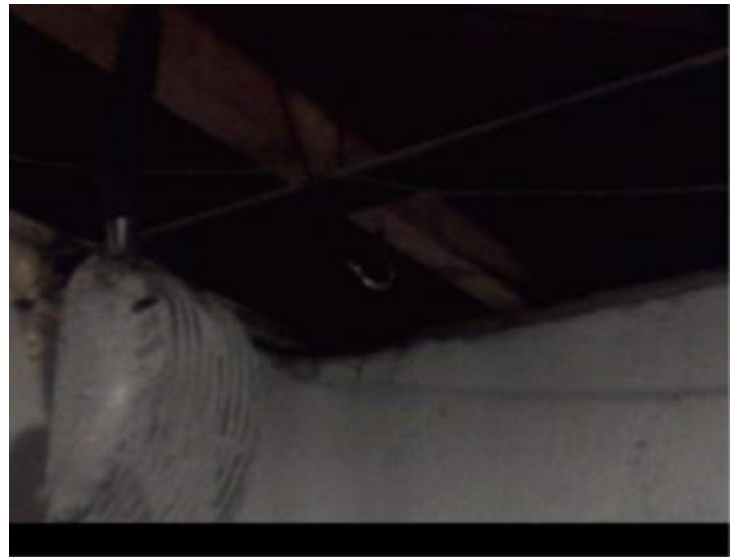
Thermal Image of basement wall penetration.

Visible image basement wall penetration.

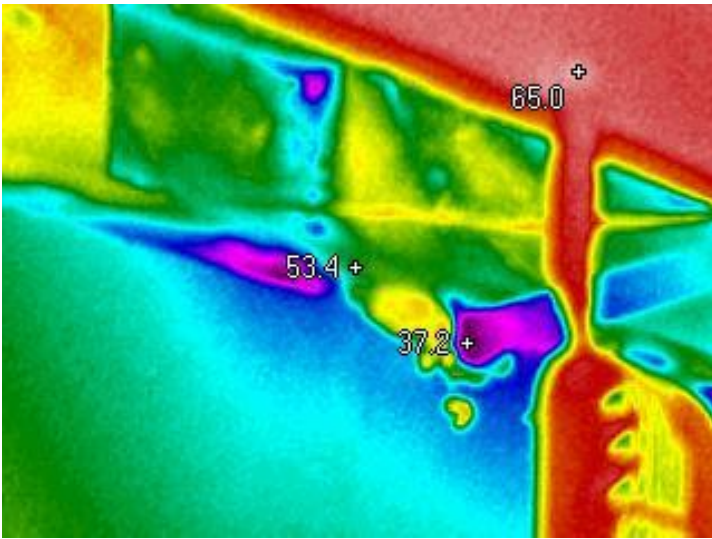
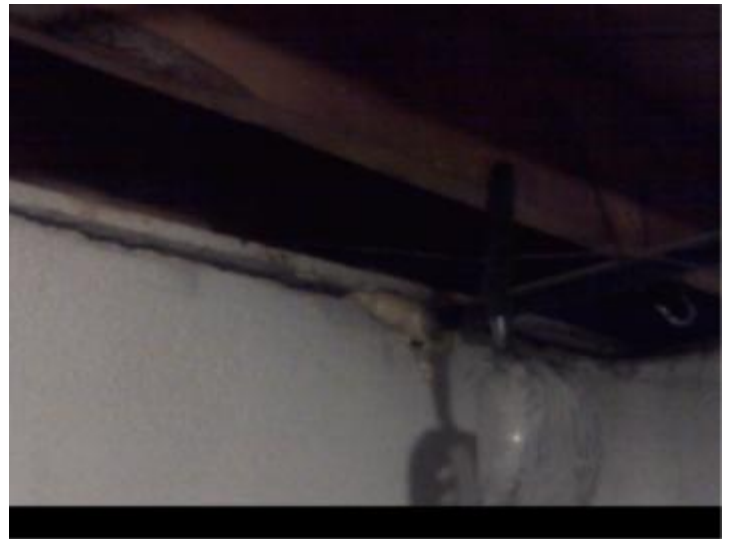
Thermal Image of plumbing penetration in basement wall and poorly sealed rim above foundation wall.

Visible Image of plumbing wall penetration.

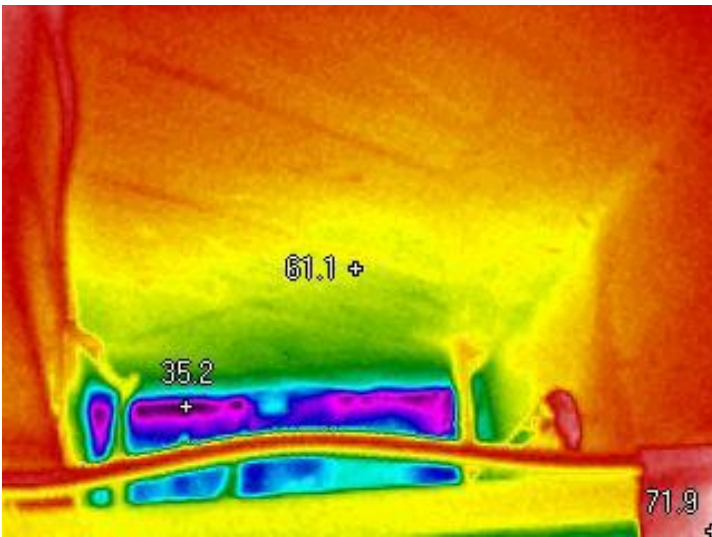
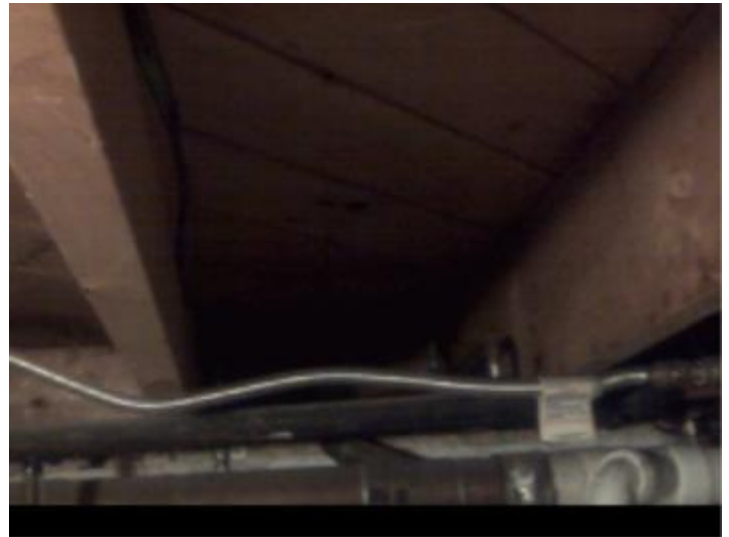
Thermal Image of rim and band joist, needs to be sealed and insulated.

Visible Image of rim and band joist.

- Currently there is no insulation above sill plate between floor joists
- Recommend Air Sealing sill plate, rim and band joists on all exterior foundation walls and Air Sealing foundation wall adjacent to garage
- Recommend Insulating above sill plate on all exterior foundation walls and wall adjacent to garage

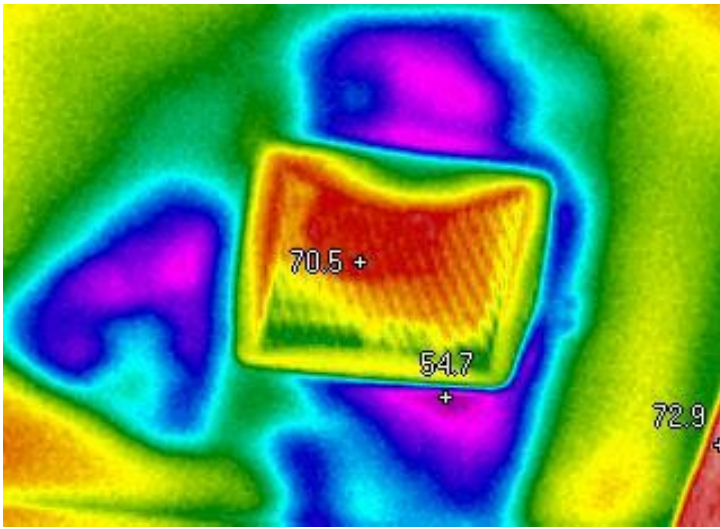
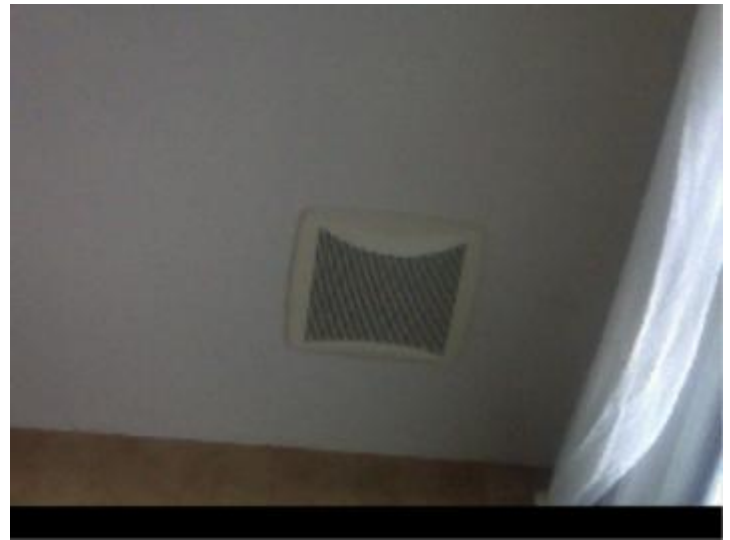
Thermal Image of ceiling vent, needs to be sealed properly.

Visible image of ceiling vent.

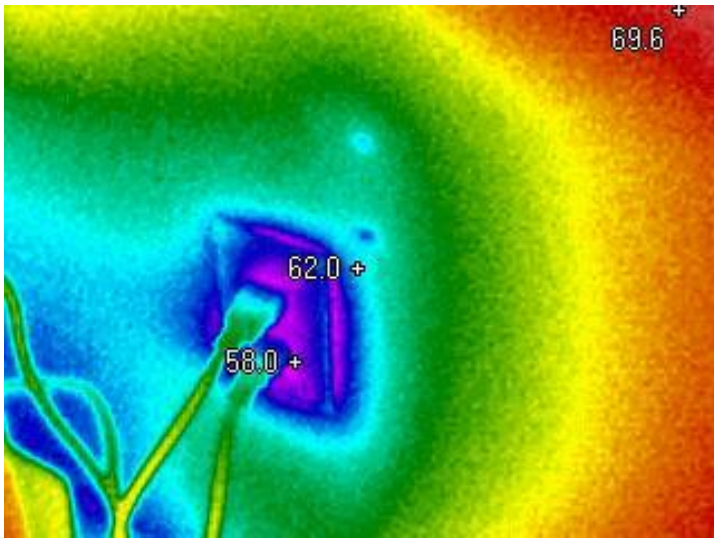
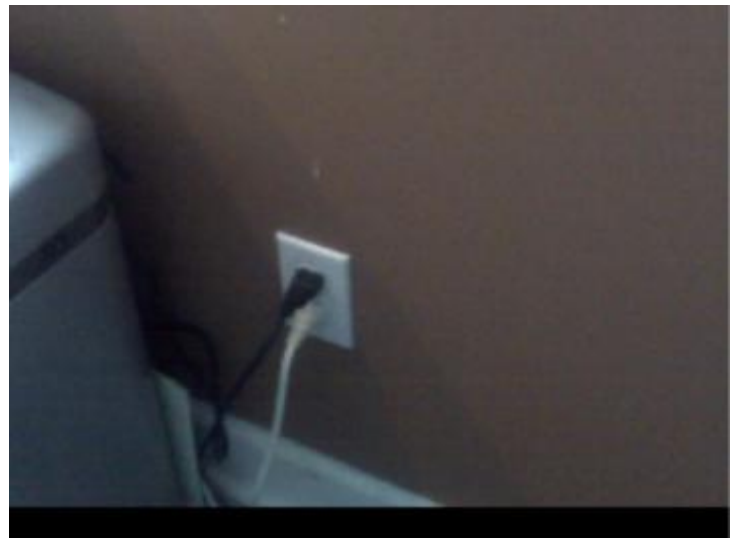
Thermal Image of Electrical outlet, needs to have a gasket or a good indication of poor insulation in wall.

Visible Image of Electrical outlet

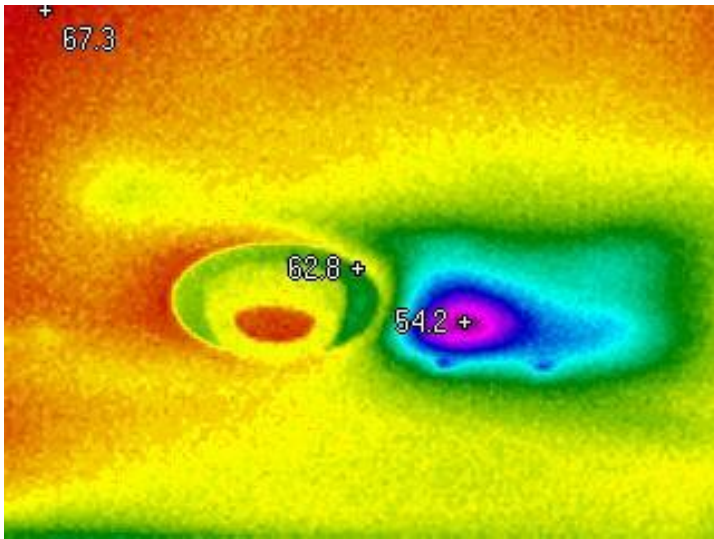
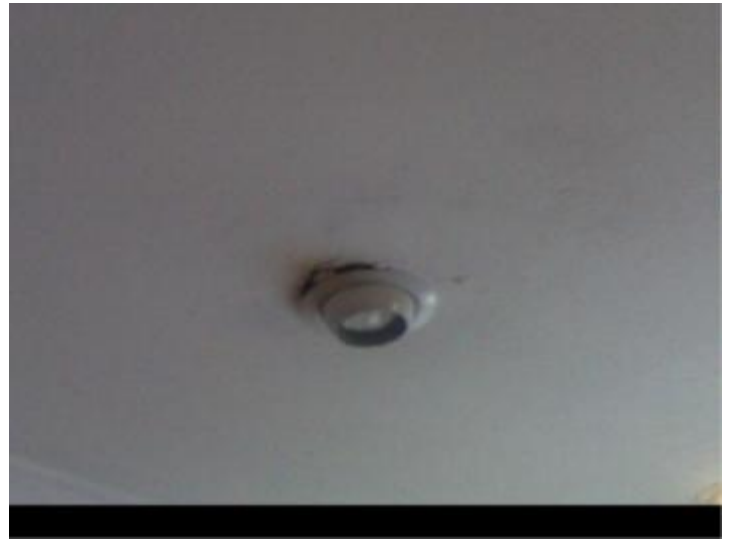
Thermal image of ceiling can light. Needs to be sealed and insulated from attic.

Visible image of ceiling can light.

- Current Recessed Lights are a source of heat loss to the attic
- Current Recessed Lights are non-insulation contact rated and should have insulation at least 3" away
- Recommend Installing Insulated Box/Can House over recessed light fixture in attic and sealing box to attic floor

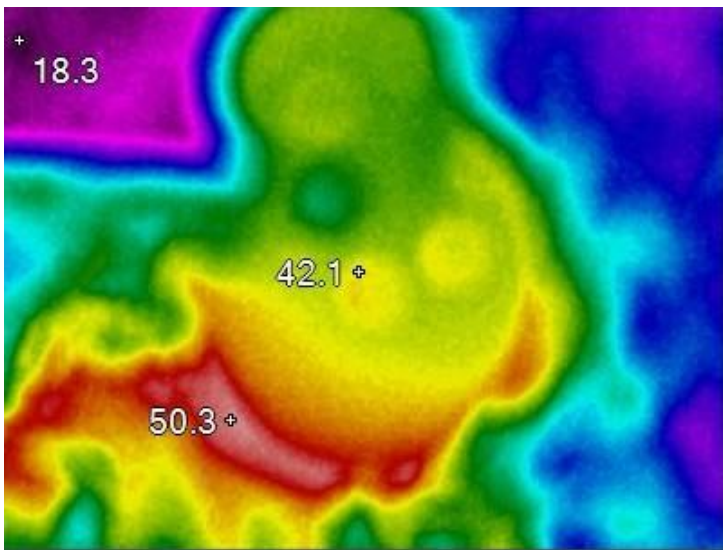
Thermal image from attic of Can light, showing conditioned air leakage to the outside

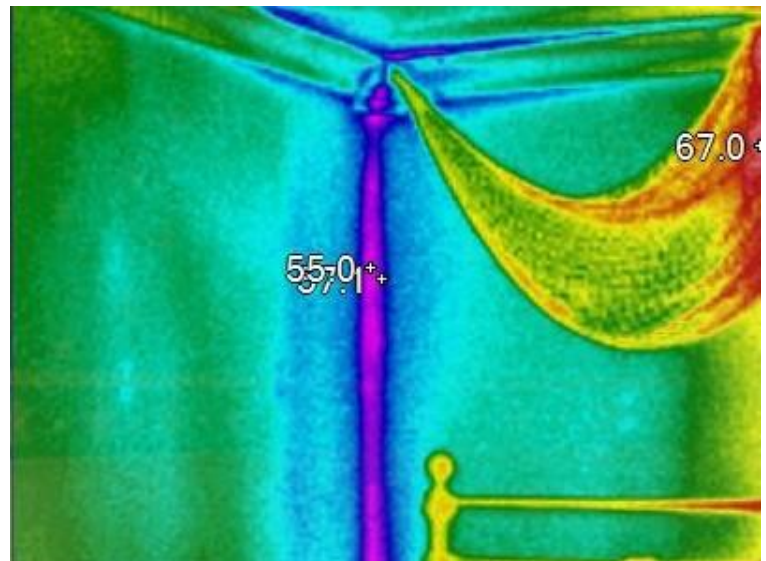
Thermal image of bedroom exterior wall showing adequate insulation in walls.

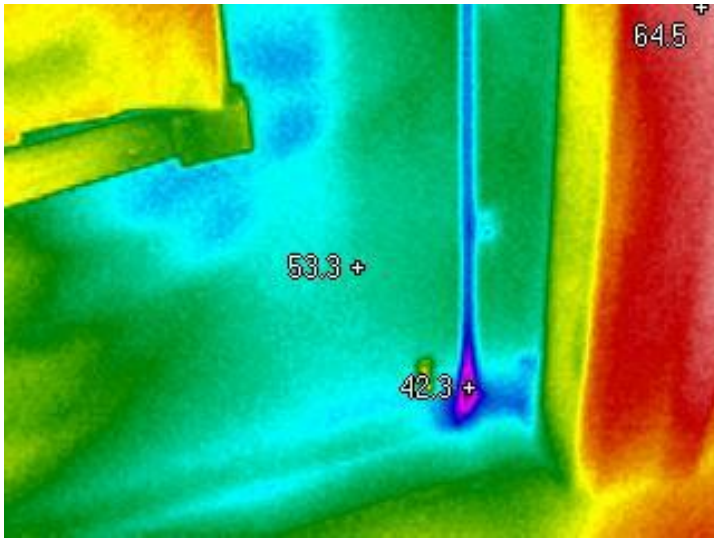
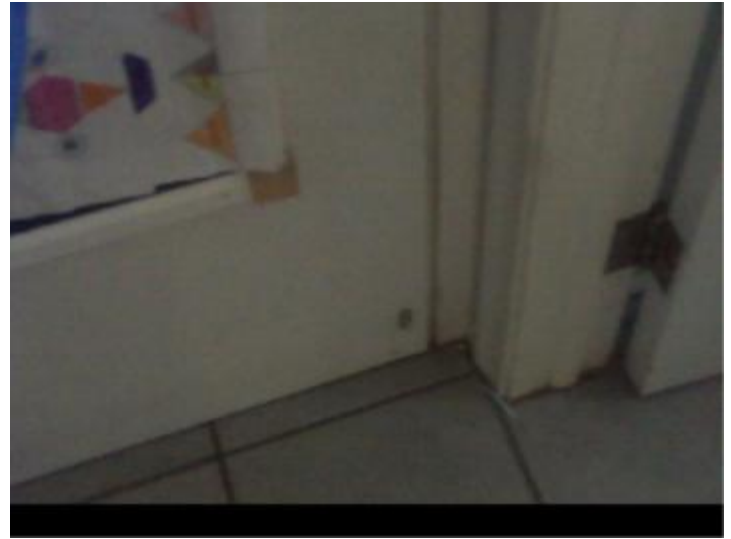
Thermal image of garage door needs to have additional weather stripping.

Visible image of garage door.

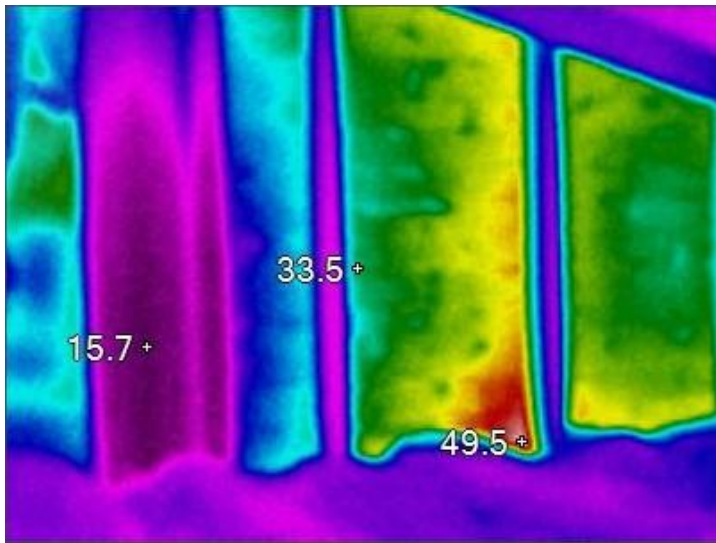
Thermal image attic fireplace chase from attic.

- Currently the Fireplace is not sealed off from the outside. The Fireplace Chimney is allowing outside air to infiltrate the home at its base entering the conditioned space of the home from the basement and the family room.
- Recommend Sealing entire Fireplace Surround in Family Room
- Recommend Adjusting Fireplace doors so they close securely and seal
- Recommend Sealing Chimney Outdoors to stop the infiltration of air indoors
- Recommend Sealing and Insulating Fireplace Chase in the Attic to Stop exfiltration of conditioned air into the attic

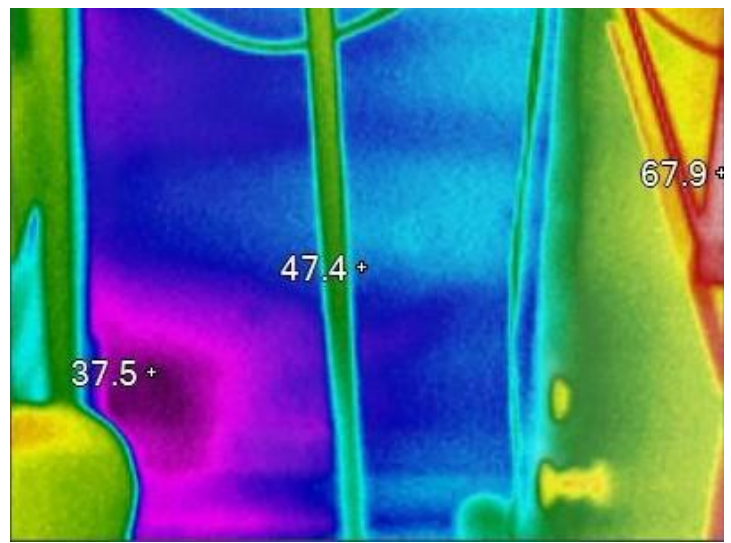
Thermal image of cold wall

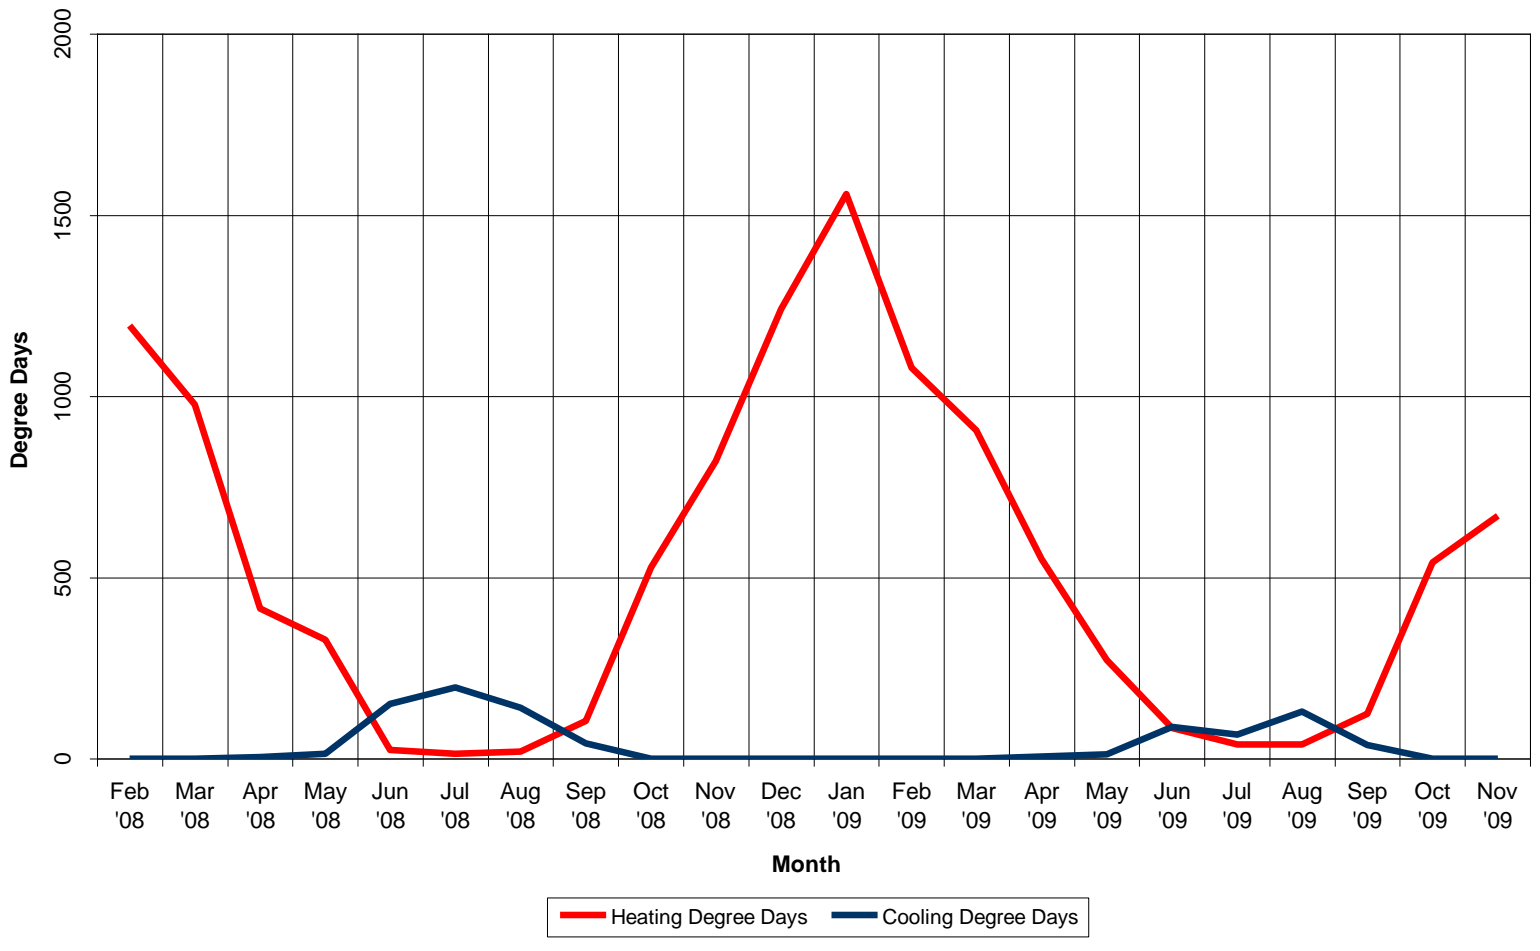
Monthly Weather Chart

Degree-day, (HDD or CDD) is a unit of measure used to estimate the fuel and power requirements in heating and cooling a building; it is equal to a difference of 1 degree between the outdoor daily average temperature (the mean of the maximum and minimum daily dry-bulb temperatures) and a reference temperature. Degree-days are an indicator of how far the average temperature departs from a human comfort level called the base. In the United States the base is generally 65°F. For example to calculate the CDD, take the average of a day's high and low and subtract 65. For example, if the day's average temperature is 80F, its CDD is 15. If every day in a 30-day month had an average temperature of 80F, the month's CDD value would be 450 (15 x 30).
